¹Miroslav MILUTINOVIĆ, ² Spasoje TRIFKOVIĆ, ³ Aleksije ĐURIĆ, ⁴ Nikola VUČETIĆ

GEAR FAILURES EMBEDDED IN MANUAL GEARBOXES

¹⁻⁴ University of East Sarajevo, Faculty of Mechanical Engineering, East Sarajevo, BOSNIA & HERZEGOVINA

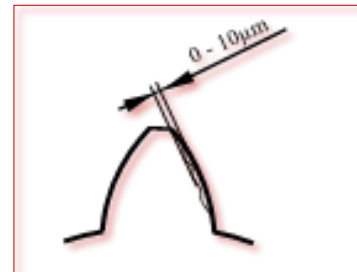
pitting. The process can be identified with the naked eye as a gray color or spots on the flanks, which represents the formation of micro cracks or dimple depth up to several microns. Figure 1 shows a schematic representation of damage due to micro-pitting and Figure 2 presents the resulting micro pitting on the side of the gear. Identical damage is possible on the gear that is built into the gearbox.

Figure 1. Micropitting

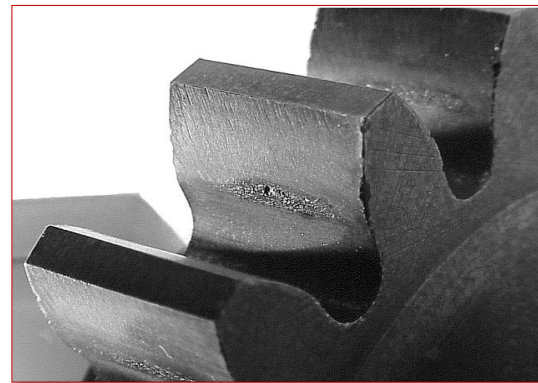
Figure 2. Micropitting[2]

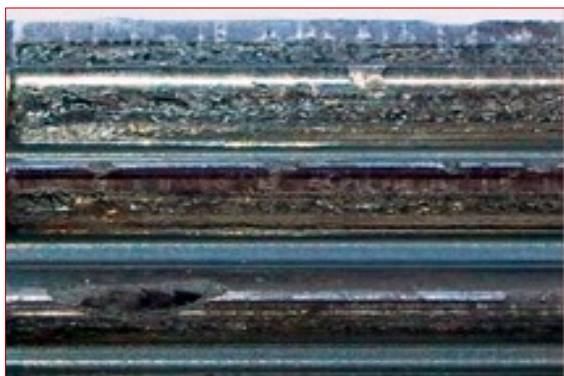
Figure 4. Gear pitting failures [12]

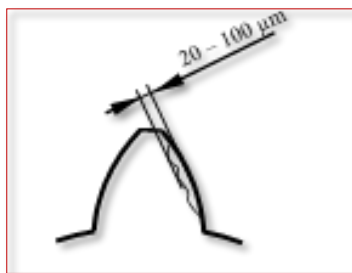
Spalling is another form of failure of hardened gear tooth flanks. It is characterized by appearing as a brittle fracture. Spalling is characterized by the appearance of cavities of several tens of microns to 0.2 mm (Figure 5) i.e. from 0.25-0.35 to the half of length of the contact line on gears flank [13].

Figure 5. Spalling

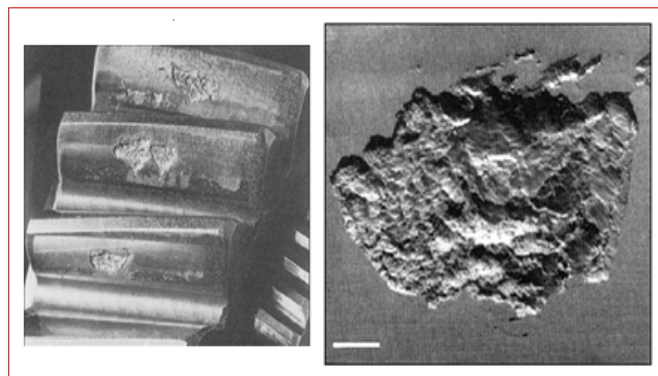
of torn particles. In the case of surface hardened gear flanks, separation of larger pieces of the gear surface layer is occurred, whereby the bottom of the fracture is usually between hardened and unhardened layer. On gear damages caused by spalling, the characteristic sharp edges along the surface can be noticed. Initial cracks are small, and when the number of such particles accumulating in one place creates larger cracks. Figure 6 presents the damage due spalling on the gear flank.

Figure 6. Spalling [14]

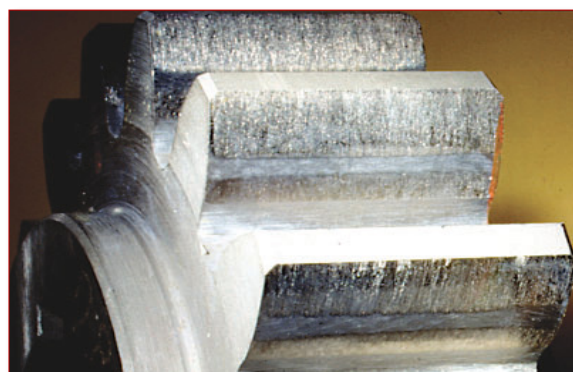
Scuffing is a type of gear failure, which is manifesting by large number of longitudinal damages in the form of furrows in the direction of sliding (figure 7). The position of furrows depends on the contact surfaces (Figure 8).

Figure 7. Gear scuffing failures [12]

The cause of this type of damage is interruption of oil film between the contact surfaces of the gear flanks caused by overload or high sliding speeds.

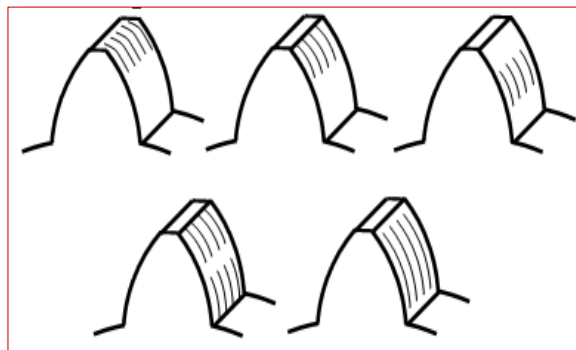
Figure 8. The position of furrows due to scuffing damage

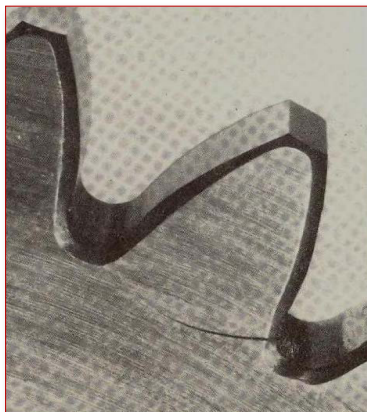
Figure 9. Crack of tooth root [14]

One example of a crack in the root of the tooth is shown in figure 9, while figure 10 shown breakage of more gear teeth caused by a high-cyclic fatigue. During the work of gearbox comes to rapid changes of loads that directly act on the gears. Load changes influence directly the expansion of initial cracks, and thereby to gear breakage.

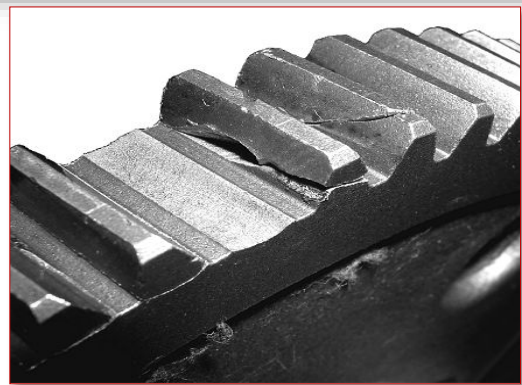
Figure 10. Breakage of more gearteeth [15]

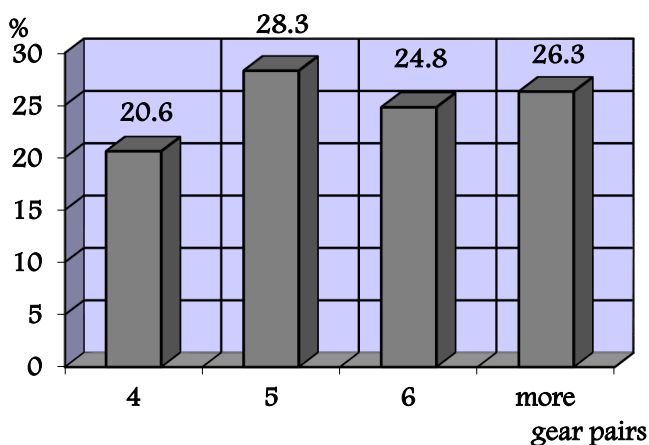
Significant damages of the gears which are embedded in manual gearboxes emerged after 900.000 km. Respondents maintained manual and automatic gearboxes. In this paper only the analysis of manual gearboxes are included. Figure 11 shows the percentage of failures for different types of manual gearbox. The largest number of defects was emerging at the five-speed gearboxes. In addition to damage to the gears, failures on the sealing seams and synchro coupling were occurring.

Figure 11. The percentage of failures for different types of manual gearbox

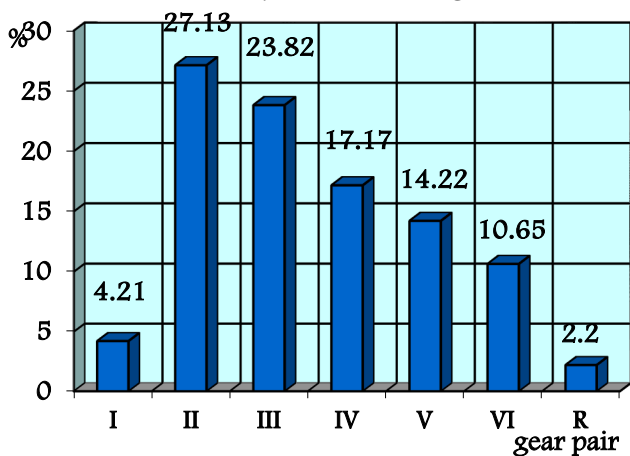
Damage to gear pairs is generally created after driving 300.000 km and more. These damages are more balanced by freight motor vehicles which are driven across different terrains, while by freight motor vehicles, which are driven across mountainous terrains, damages appeared to lower gearbox speeds. In the case of vehicle driving only across lowland terrains, damages were created to higher gearbox speeds. Figure 12 shows the diagram of gear pairs damages for each respective speed of six-speed gearbox, for freight motor vehicles which were driven across different terrains.

Figure 12. Diagram of gear pairs damages for each respective speed of six-speed gearbox
During the disassembly of each gearbox, verification of all elements was carried out and the possible damages were determined. Types of damages have
