¹I.H. IVANOV

DESTRUCTION OF A CAST IRON CYLINDER HEAD IN OPERATION AND AFTER WELDING RECOVERY

¹ University “Prof. dr Asen Zlatarov”, Burgas, BUGARIA

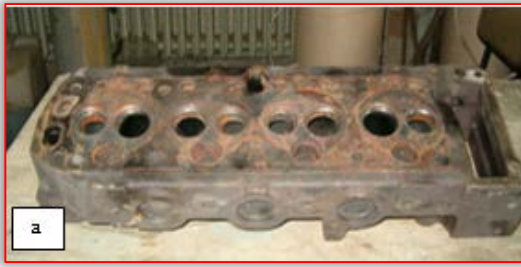
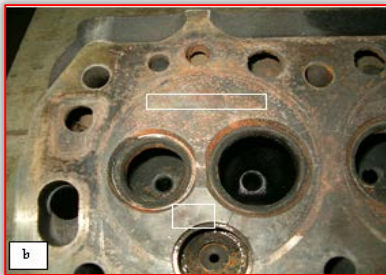
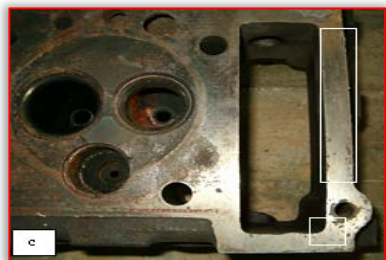
Samples taken from the combustion chamber (Figure 1) and from the place with the least heat load (a side wall of the first cylinder) were tested. The thickness of the walls, where the samples were taken from, was identical, in order to avoid the influence of the scale factor on the structure and casting properties.

Figure 1. Cast iron cylinder head of a car Opel Omega 2.3 TD with the place of the samples

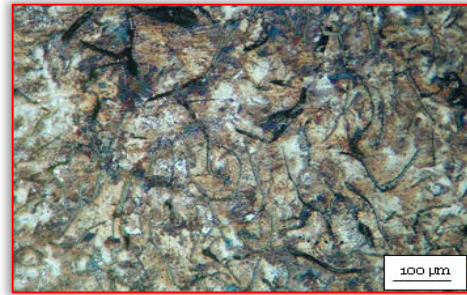
During details repair determining the chemical composition of the details is not always economically feasible. That is why determining the cast iron type was performed by examining its microstructure and mechanical characteristics. Microstructural base material of the cylinder head was cast iron with lamellar graphite Fig. 2 with Brinell hardness 195-200 HB.

Figure 2. Microstructure of the base material of the cylinder head

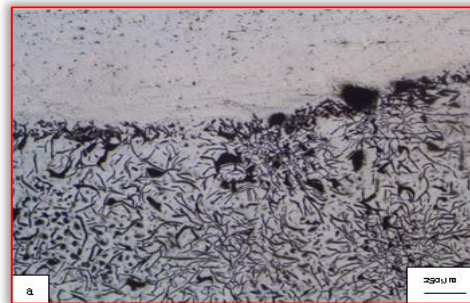
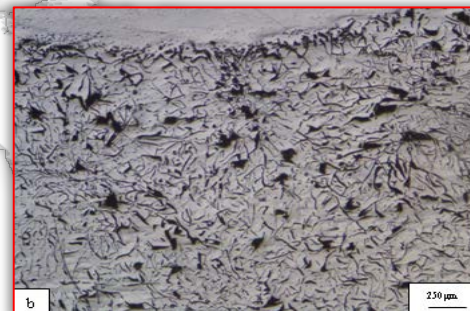
The tensile strength of the samples taken from the combustion chamber was $R_m = 185 \div 200$ MPa and those on the outside wall - $R_m = 220$ MPa. The metal ferrite-pearlite matrix had predominantly pearlite structural component. Modification of the structure was observed in the combustion chamber due to the beginnings of graphitization of carbon from the

cementite. It was a consequence of the increased diffusion capacity of the carbon at high temperatures, the combustion chamber material was subjected Fig. 3.

Figure 3. Microstructure after welding of cylinder head in the combustion chamber - a) and the base material - b)

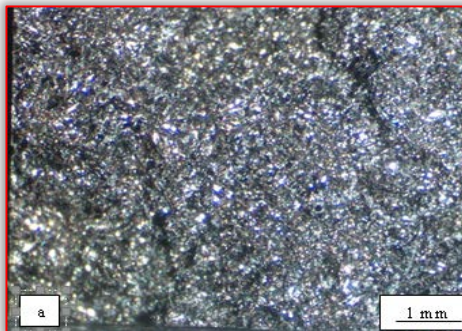
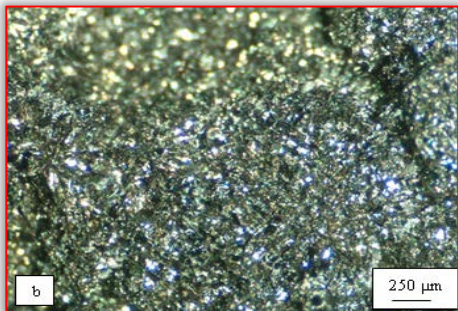
Corrosion processes occurred at grain boundaries and at the most intensive border between the graphite and metal matrix. Due to the cyclicity of engine operation and the continuous change of the gas phase temperature - from 360 to 2200 °C, the material was subjected to prolonged heat fatigue [3,4,7]. It caused the appearance of microcracks and their development

in depth until the connection of the fuel space with the water space in the cylinder head. From the continuous observations of details with similar defectiveness it was found their predominant generation and development in two main areas: first, at places where the combustion process was most intensive (pre-chamber - inlet valve); and second, at places with sharp edges, smallest section and relatively low cooling (between the valve seats)[1,3,9].

Figure 4. Fracture surface of cylinder head in the combustion chamber after tensile testing

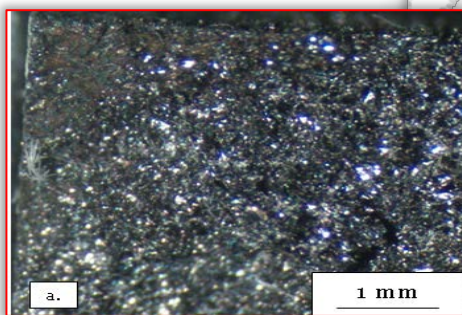
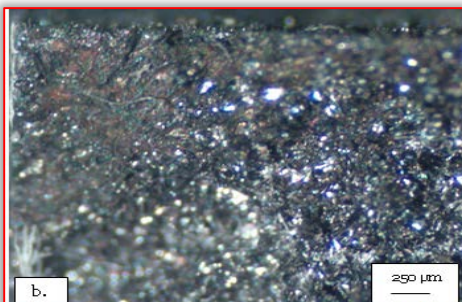
Figure 5. Fracture surface and corrosion of cylinder head in the combustion chamber after tensile testing
During operation the main cause of damage to the details was the stress of tension arising from the non-

free change of the workpiece size in the presence of a temperature gradient between its parts. As a result of the heat significant local extensions of the detail took place, and this happened at a time when the volume of the cold detail remained constant due to the low thermal conductivity of cast iron. This led to the formation of internal stresses. Their accumulation led to the formation of cracks during detail operation. Some major differences between the samples were identified during the analysis of tensile testing fractures. Microcracks had been created during operation in the cast iron that was subjected to prolonged thermal and oxidative stress. With time the microcracks had developed into macrocracks with growth direction from the surface of the material into its depth Fig. 4a and b. The reasons for the cracks' occurrence and growth were the above-mentioned corrosive processes, thermal fatigue, low silicate fatigue, as well as the high pressures which, under extreme conditions, reaches 0.8-0.9 MPa.

Figure 6. Fracture surface of cylinder head from the wall a) and the combustion chamber b) after tensile testing
Probably the spread of the cracks affects the vibrations in the engine. The material on the cleft surface was highly oxidized and the characteristic yellow-brown colour is observed in fig. 5 a) and b). The destruction of the material during the tensile testing continued along these microcracks. The fractures of the samples of the material, which was not subjected to thermal and oxidative stress, lack cracks and oxidation in depth - Fig. 6a.

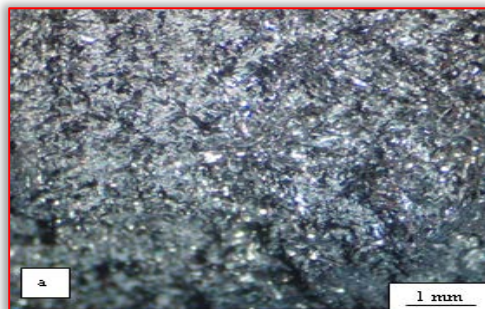
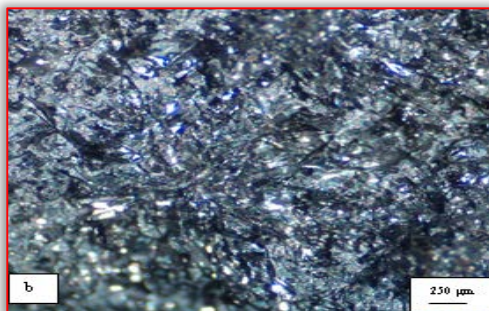
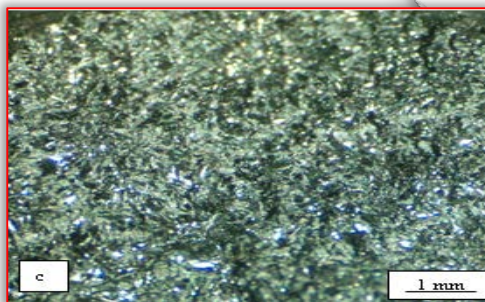
After the welding of the samples, the differences in the tensile strength increased. In all specimens the destruction in tensile testing occurred in the heat affected zone. The decreased strength of the welded samples may be explained by the presence of many

defects and the occurrence of brittle phases in the transition zone and the heat affected zone. Furthermore, the presence of oxides in depth creates prerequisites for cavities of the welded joint as depicted on Fig. 7 c.

Comparing the stresses at which the destruction of the welded samples of the wall and the combustion chamber occurred, a difference of 20-30% was observed. This was mainly due to increased porosity on the bottom of the weld pool compared with the samples from the wall.

Figure 7. Fracture surface of cylinder head from the combustion chamber after tensile testing
