DESTRUCTION OF CRANKSHAFTS FROM INTERNAL COMBUSTION ENGINES

¹ Zangador Research Institute – Varna; University “Asen Zlatarov” – Burgas, BULGARIA

Keywords: Crankshaft, fatigue, cracks

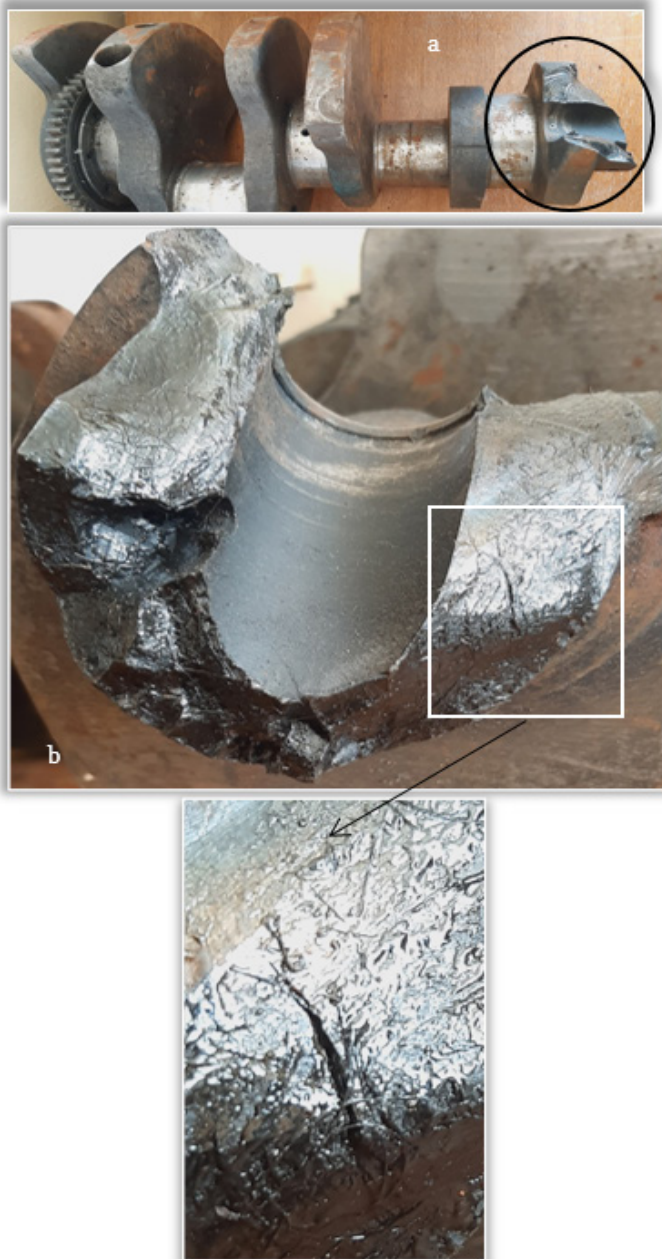
Figure 3. Destroyed cast iron crankshaft from a truck: a) general appearance and place of destruction b) secondary crack "closed type"

Regardless of the reasons for the appearance of the secondary cracks, their propagation is facilitated by the sign-changing stresses arising during operation of the crankshaft and their concentration at the sharp edges. When examining the destroyed cast iron crankshaft, significant deformation was observed in the crank pin journal, which can be explained by the sudden destruction during engine operation and the impact that occurred between the connecting rod and the cylinder block (the cylinder block was also destroyed).

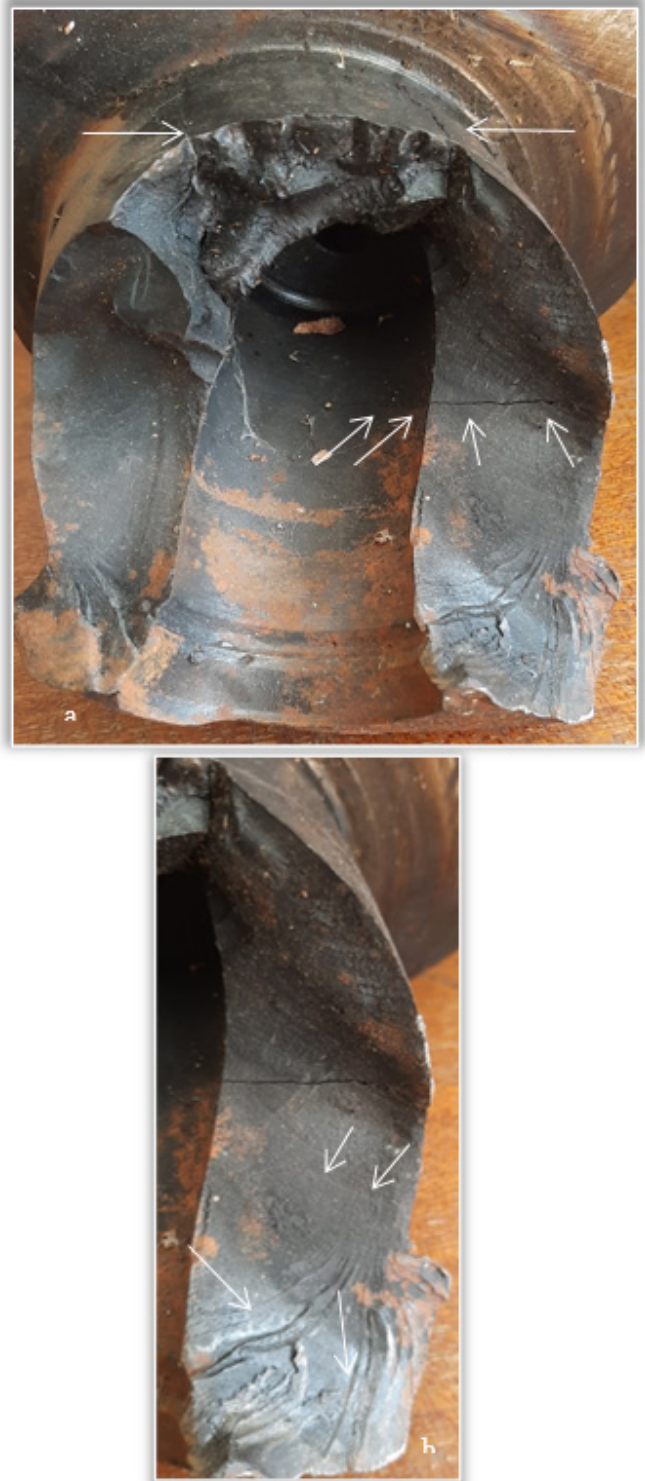
Figure 4. Destroyed cast iron crankshaft from a truck: a) secondary cracks "open type" b) Rivers marks.
